# Determination of the durability of some Egyptian monument stones using digital image analysis

ABOUSHOOK, M.<sup>1</sup>, PARK, HD.<sup>2</sup>, GOUDA, M.<sup>3</sup>, MAZEN, O.<sup>4</sup> & EL-SOHBY, M.<sup>5</sup>

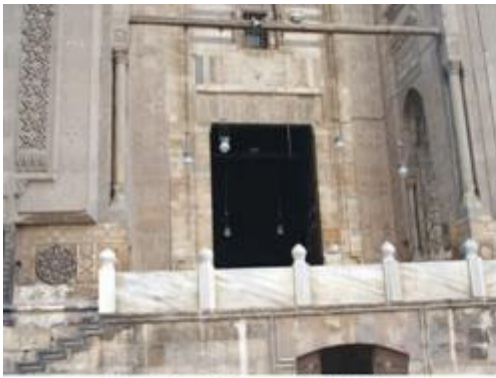
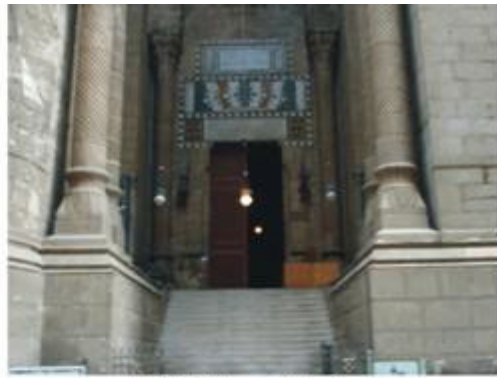
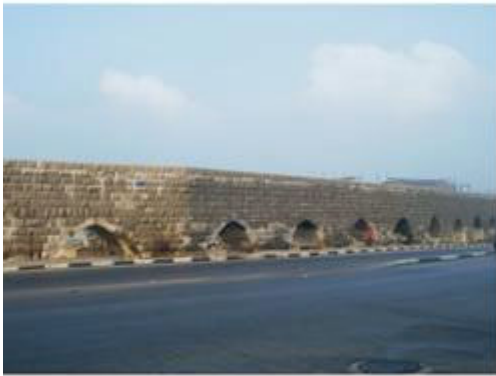
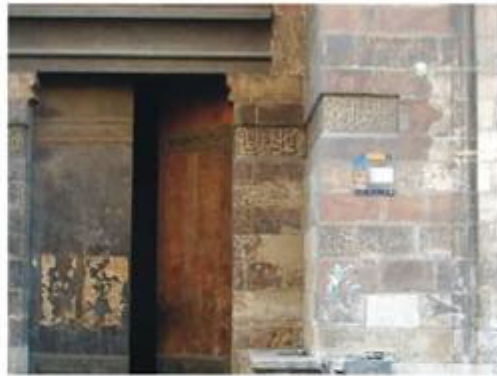
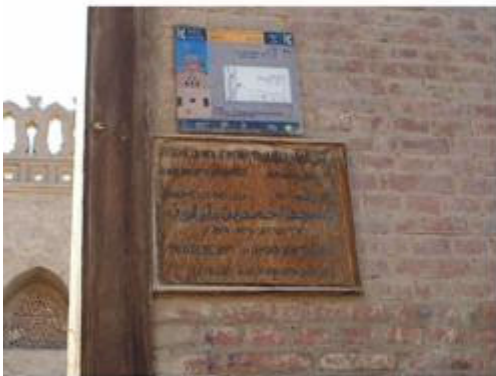
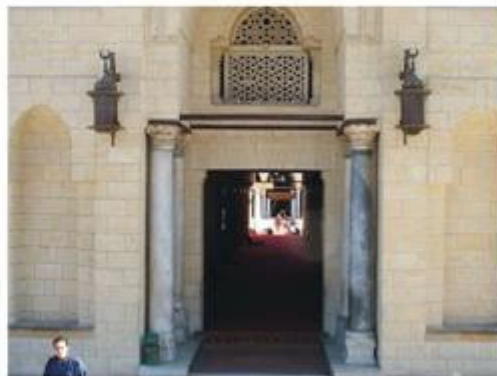
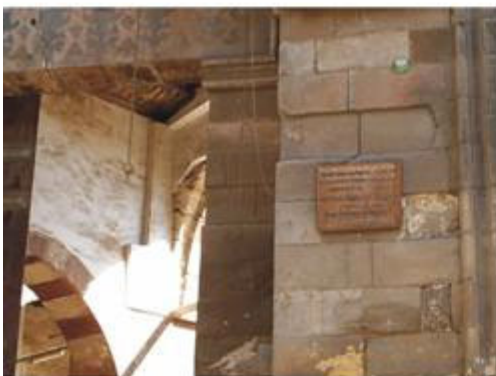
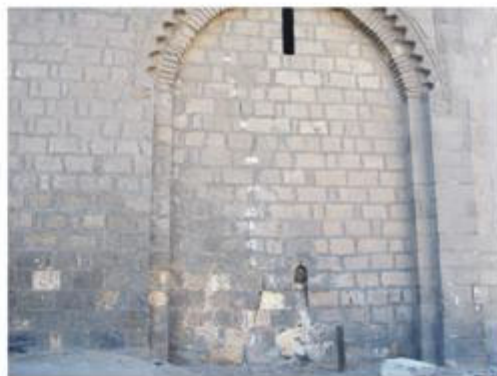
Plate 1. General views of studied sites

- General images taken of the monument walls showing the entrance and wall stones (Plate 1).
- Images taken of stone decay seen in the monument walls showing different degrees of deterioration (light, medium, high ) by the use of a digital camera (not less than 3 megapixels resolution) indicating the standard colors reference for each site (Plate 2).

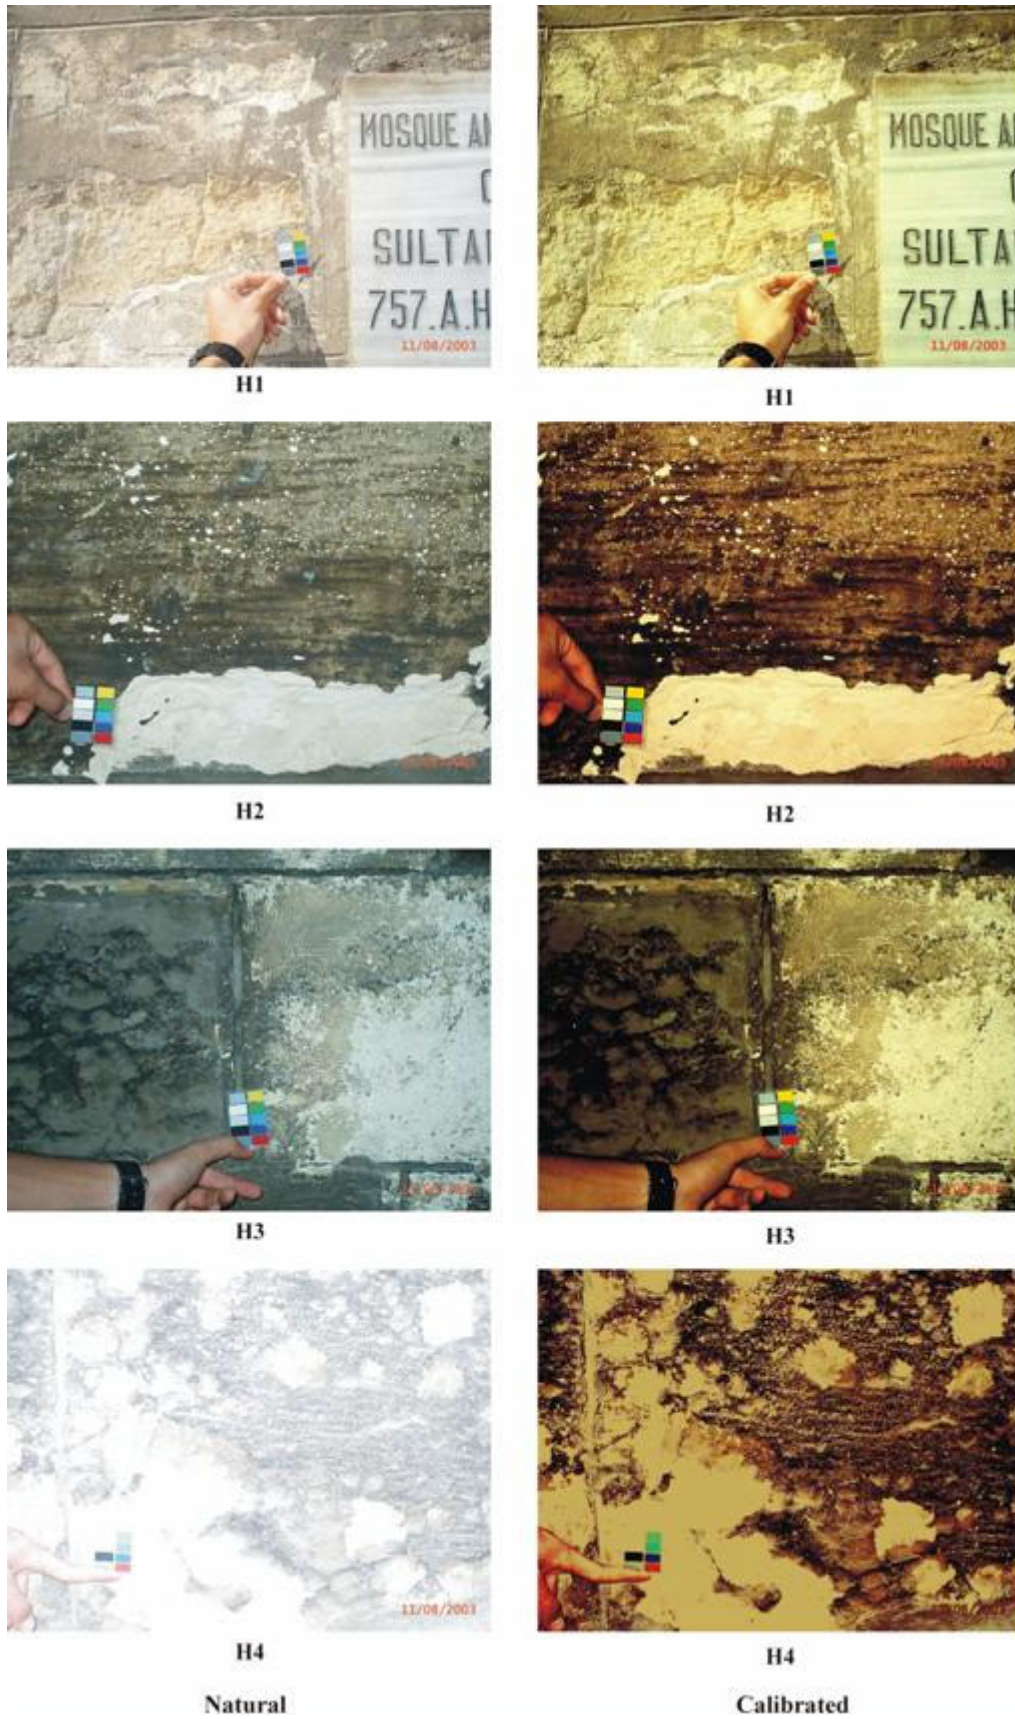
Plate 2. Natural and calibrated images of deteriorated stone in the wall of Sultan Hassan Mosque

Start the ‘ImageCraft’ program, open the digital image file that you want to analyze. Note, however, there will be some difference between the color in the digital image and real color because of shadow effects, the location of the light source etc. It will, therefore, generally be necessary to calibrate the RGB values of the digital image by using a color chart with the standard RGB values. By siting the mouse pointer over each color of the chart, the RGB values for each color can be obtained. The relational equation between the RGB value acquired by ‘ImageCraft’ and the RGB values from the standard color chart - which is included with it – can then be determined for each color (Red, Green and Blue) using the Excel software. The constants thus derived can be applied in the calibration window in ‘ImageCraft’ program allowing a new calibrated image to be generated. The calibrated image can be divided into several sections and a histogram, with relevant information and data, can then be determined for each section using the color information menu and RGB statistics in the program.

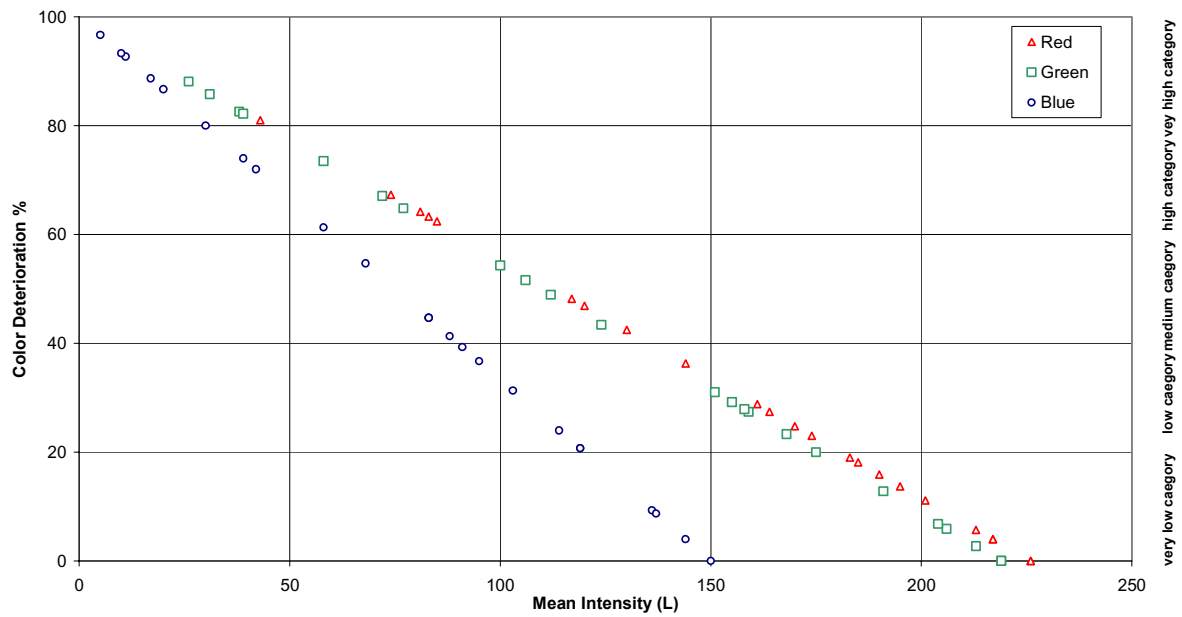
Figure 1. A classified chart to calculate number of effected color points for each proposed deterioration category ( H sites )

- Figure 1 integrates all deterioration color values in one table for each monument site.
- The ordinate of the integrated figure which represent degree of Color Deterioration is divided into five categories as follows:

- Very low deterioration (zero to 20%)
  - Low deterioration (21 to 40 %)
  - Medium deterioration (41 to 60 %)
  - High deterioration (61 to 80 %)
  - Very high deterioration (81 to 100 %)

- All Color Deterioration points for each category of the five categories indicated were calculated. Consequently, the percentage in each category was known.

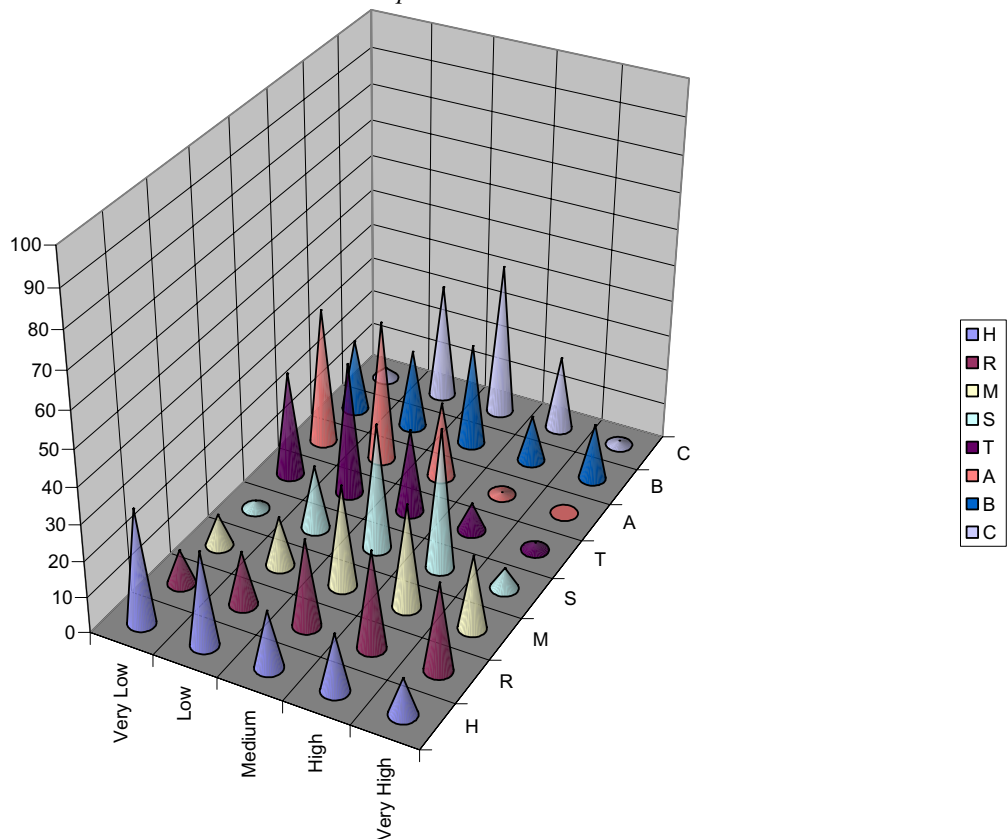
**Figure 2.** A representative chart for the proposed deterioration categories occurring in the studied monument stones. (Sites: H; R; M; S; T; A; B; C)

- General conditions of deterioration of the monument stones at the eight studied sites are presented in Figure 2.
